“The Chapel” and “The Barn” - Southern Hay Barn and Kraal c.1780

Archaeological Analysis and dating of fabric, by Hennie Vos, 2010. This plan includes the entire structure ("The Barn" and "The Chapel")

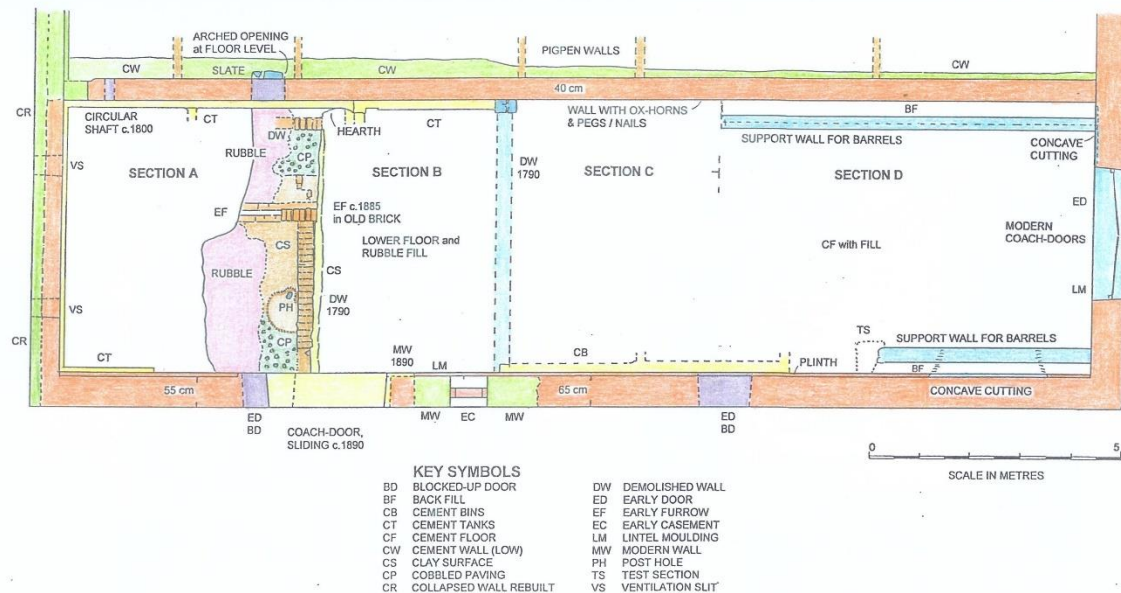
Archaeological Analysis and dating of fabric, by Hennie Vos, 2010. This plan focusses on detail in "The Chapel"

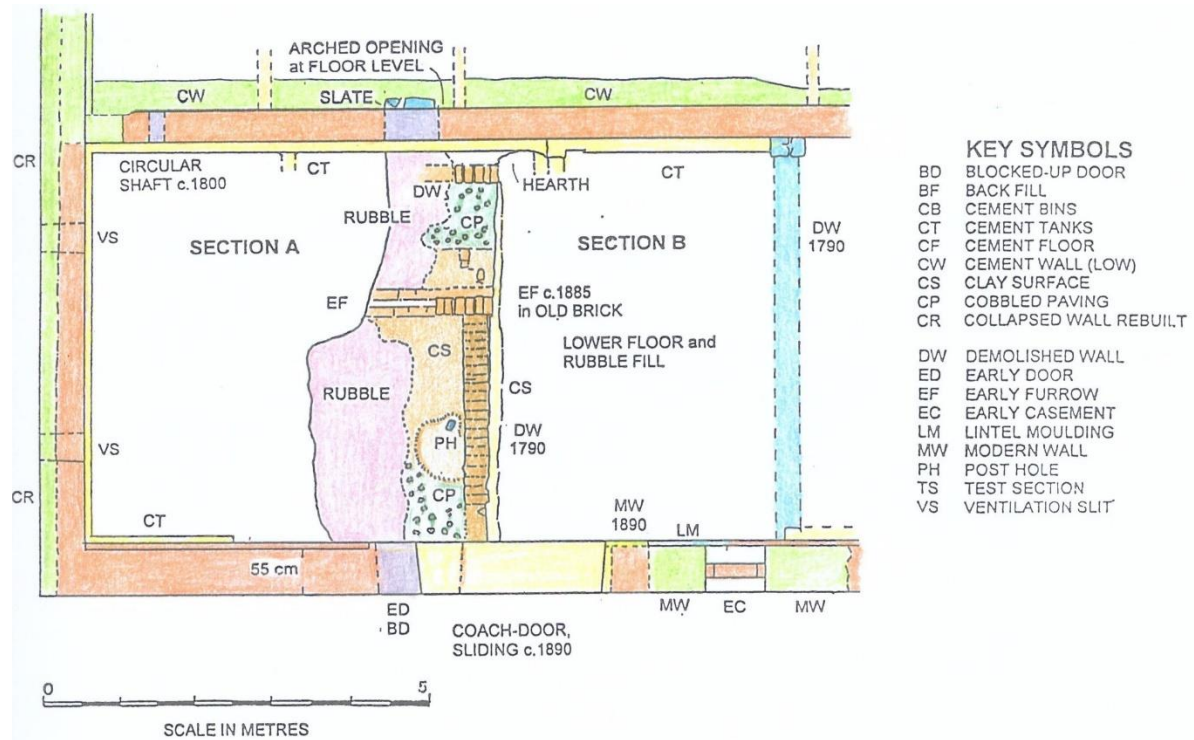
Archaeological Analysis and dating of fabric, by Hennie Vos, 2010. This plan focusses on the detail of the excavations at the podium/ upper level of "The Chapel"

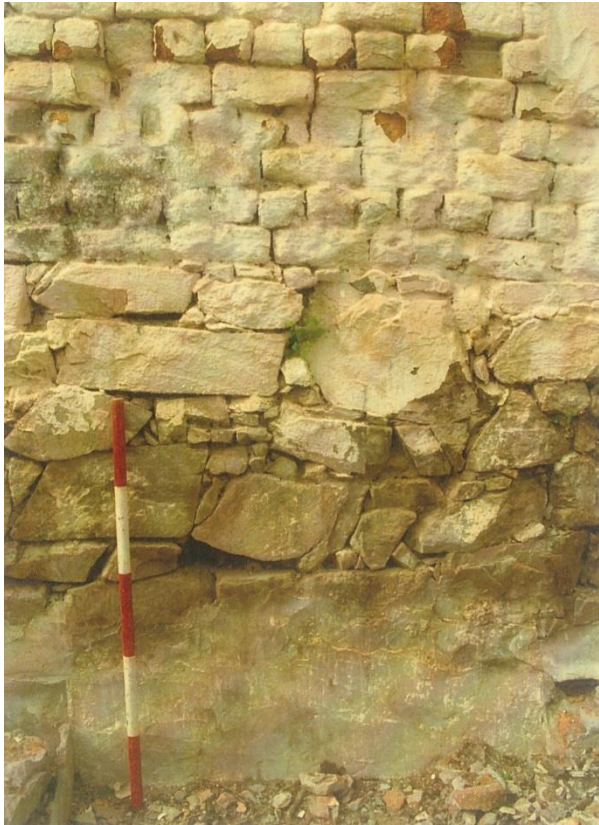
Foundation walling of Hornfels stone, with soft clay brick walls above

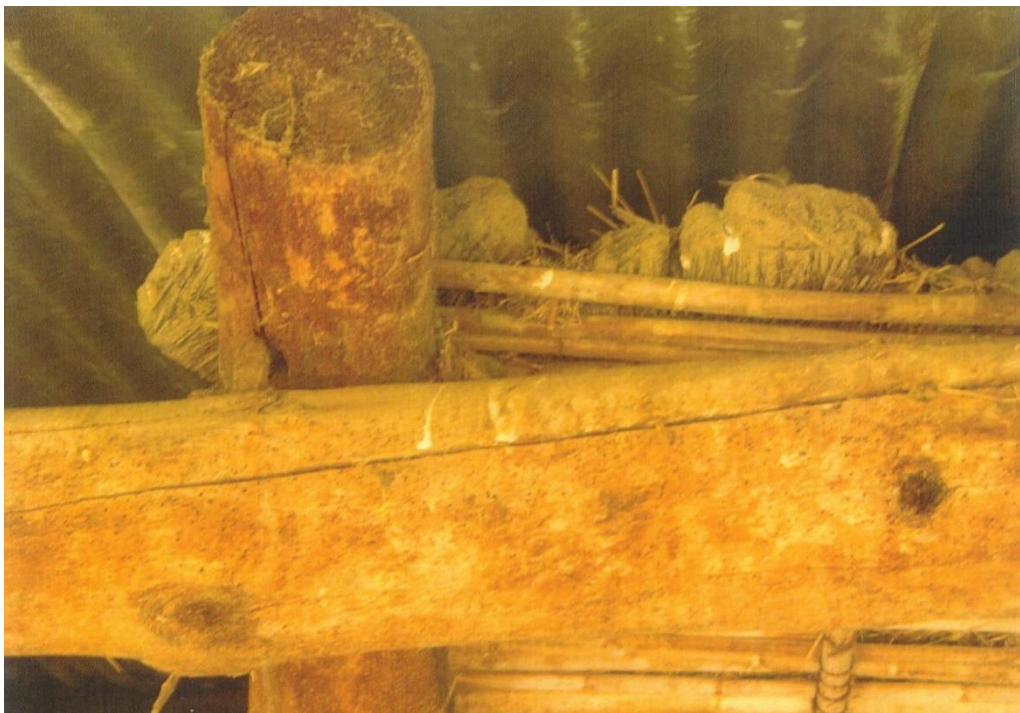
The original ceiling build up was still in place during the restoration. Note the reed ceiling, cross-reed tied with twine, the straw layer, and the clay "brandsolder" layer on top.

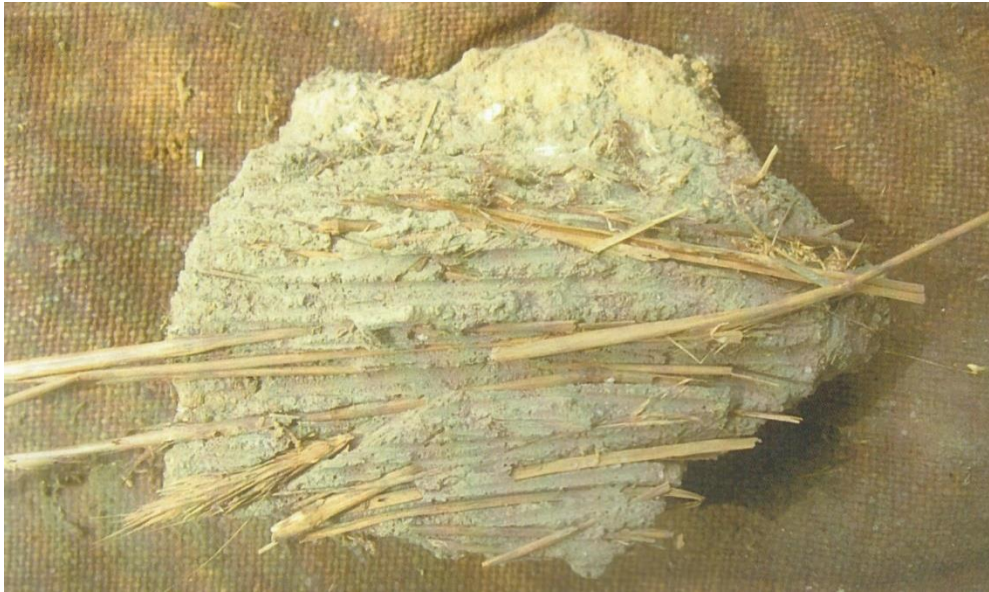
A piece of “brandsolder” material found in the ceiling. The wheat oar still in-tact. The construction of this building dates to c1780. The archaeologist found a whole hessian bag (shown behind the material), in the loft. It appeared to have contained a powdery substance.

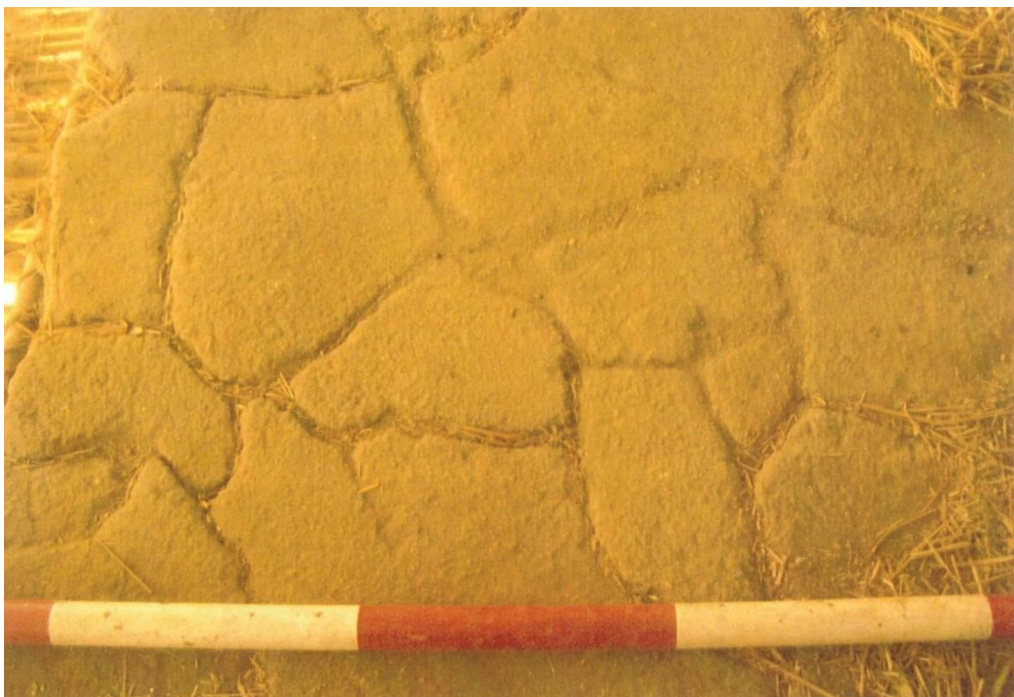
Clay “brandsolder” (fire-proofing layer) in the loft of “The Chapel”

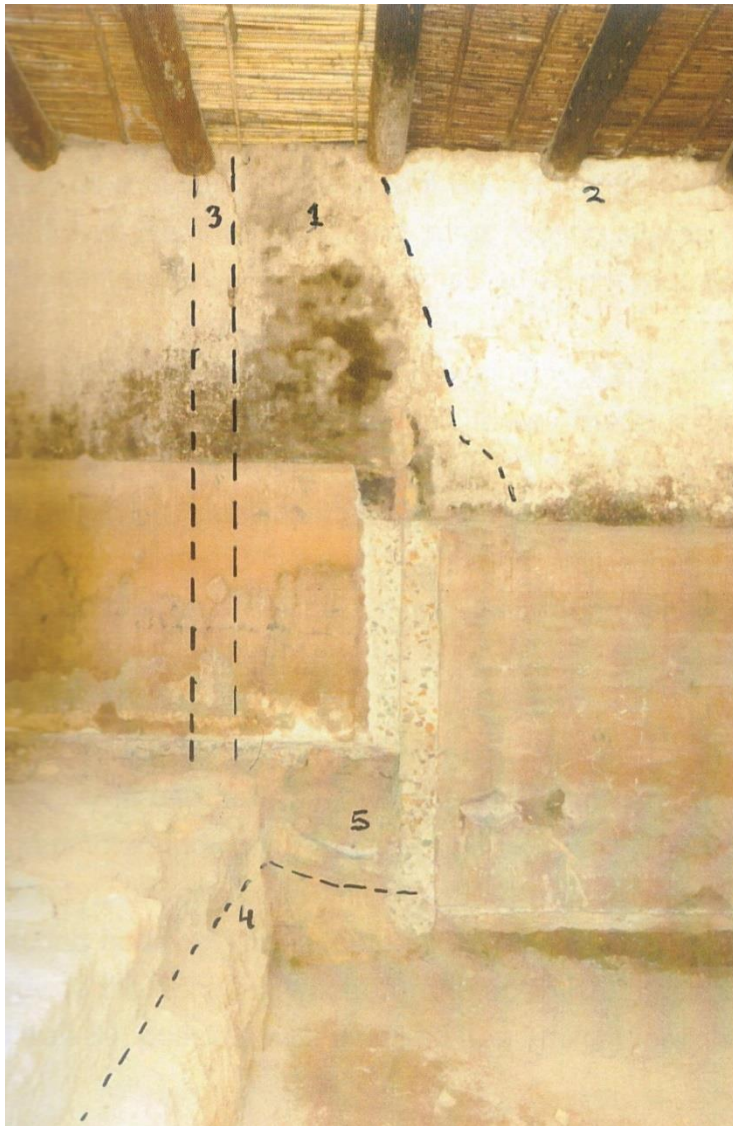
Evidence of an earlier fireplace found against the wall inside "The Chapel" – perhaps related to brandy stilling.

10. Early hearth (southern interior wall, at step in level); chimney outline in darker soot
11. Soot and smoke blackened beams – this area was in use for a long period for either distilling or as a smithy

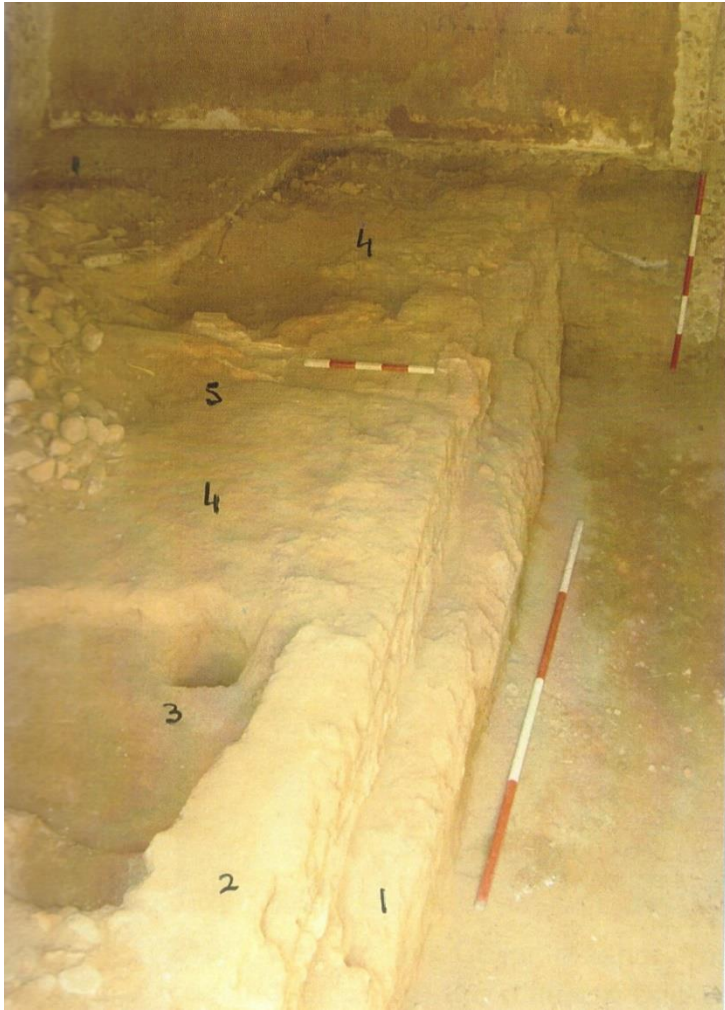
Archaeological excavation at the podium section inside "The Chapel"

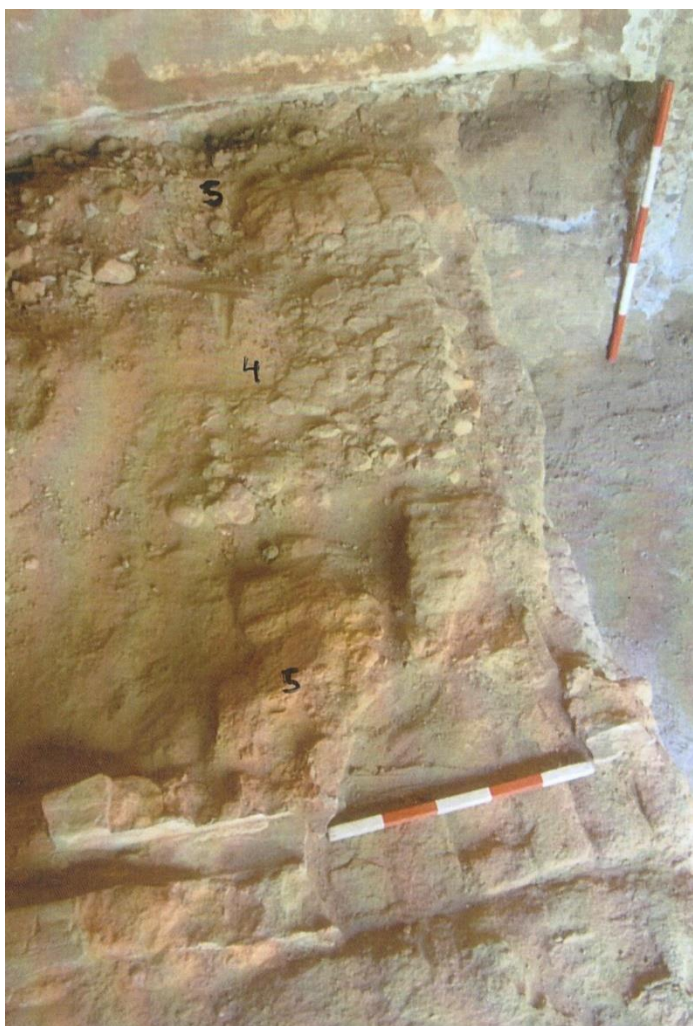
Archaeological excavation, revealing stone cobbled surface at the podium section of "The Chapel"

9. Floor (eastern end, raised area) was originally clay, but changed to compacted clay and pebble surface in the mid-late 19th century – use of the area possibly changed from wine-making to stabling of animals.

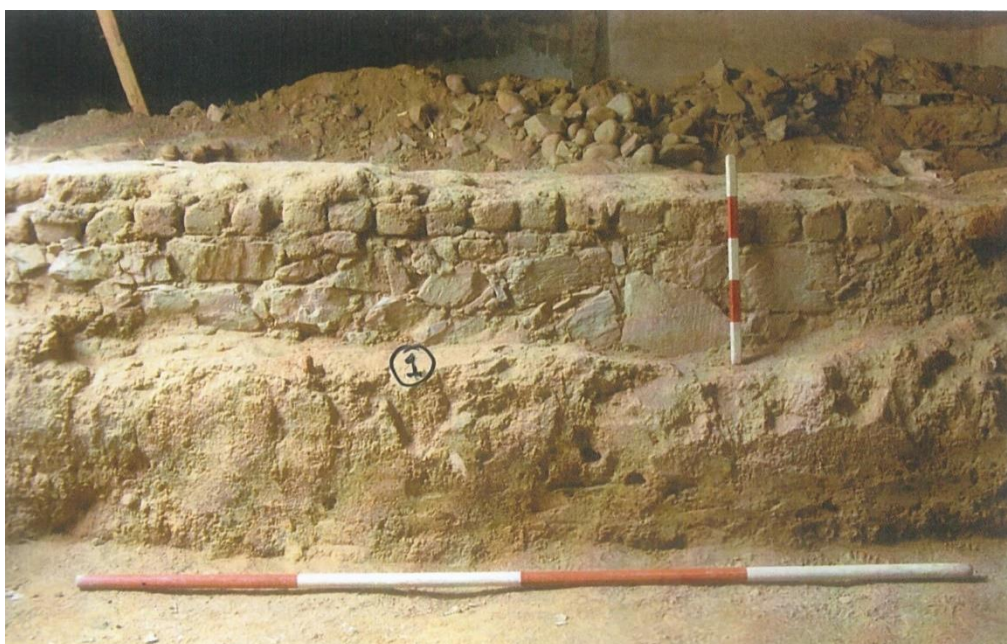
The podium section of "The Chapel" during archaeological investigation by Hennie Vos.

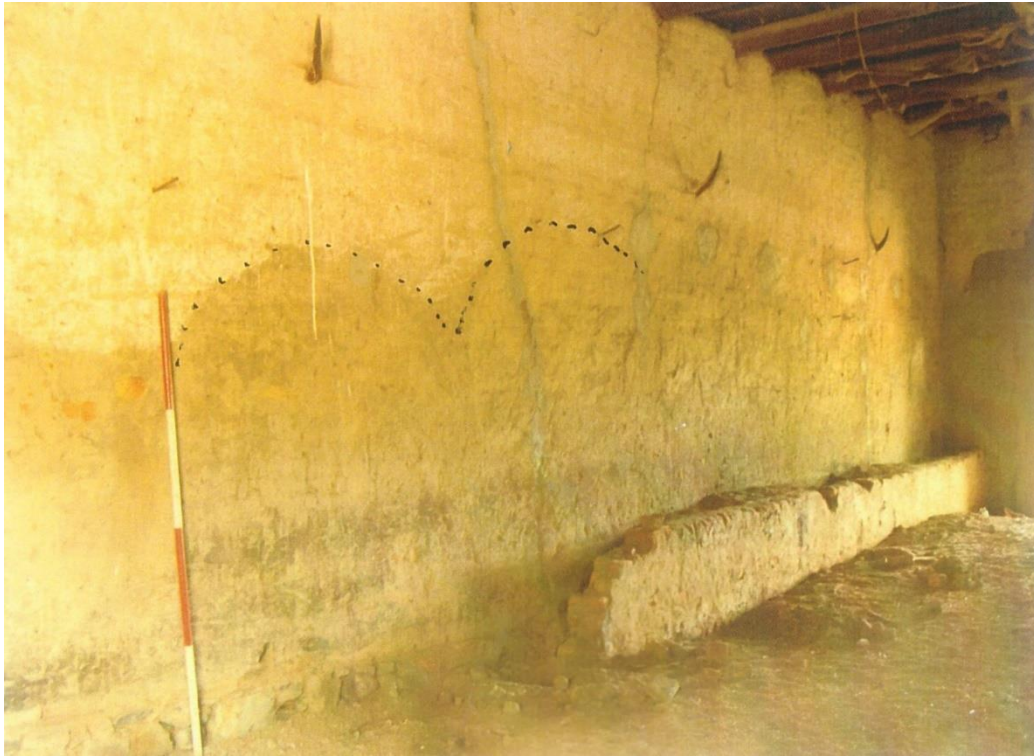
Inside “The Chapel” there are many interesting features, such as the low wall which supported casks, the darker colouring on the walls revealing the placement of large wine vats, the ox-horn hooks in the walls, the lanolin patina low against the wall, from the sheep that were kept in this area.

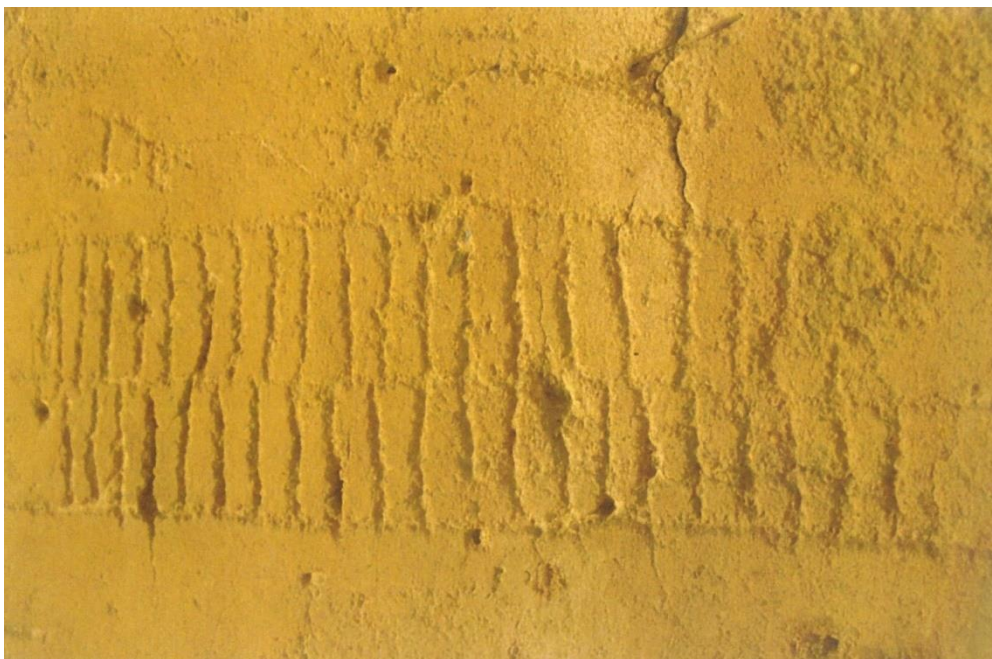
Scratched into the soft plaster of the wall, are various sheep shearers markings.

17. Sheep shearers' markings: Linear incisions scratched into plaster
18. High lintel of earlier coach door – to accommodate a wagon with hay or a high-covered wagon.
