"The Manor House" - Southern Homestead c.1750-1821

Phased development of the "Manor House":

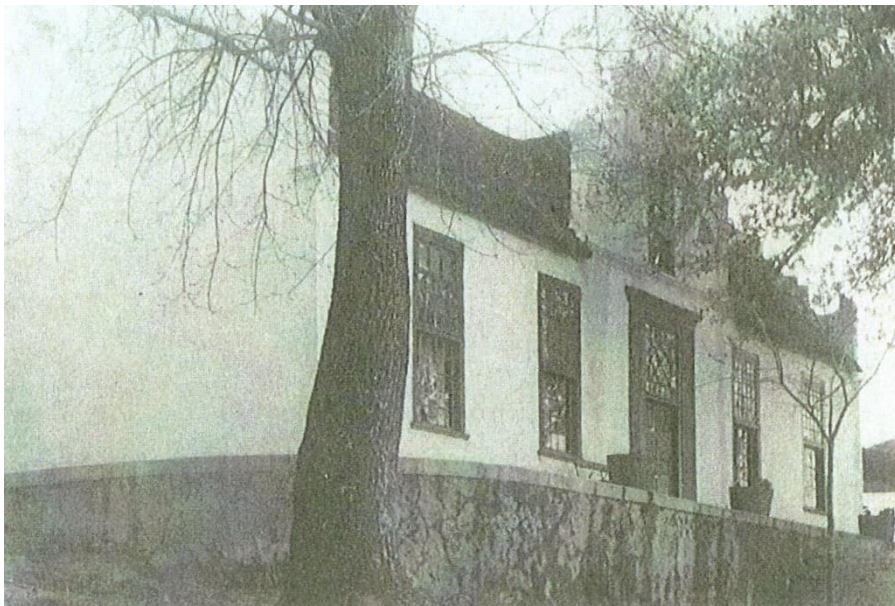
Photograph of the Manor House dating to c1964. (Fransen & Cook 1965)

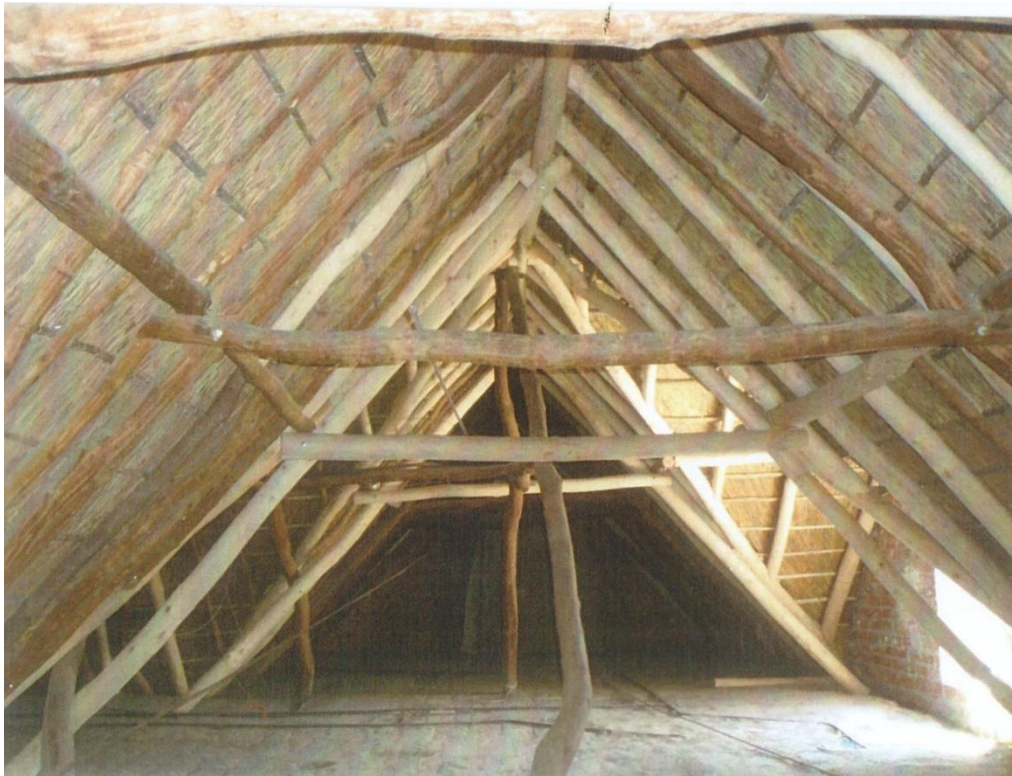
Original roof timbers have been conserved.

The timber framework of the roof for the full H-plan, appears to all date from the same period. The timber trusses have wooden peg fastenings. The loft had a 'brandsolder' of clay tiles, in a fairly unique format. It has been replaced with lightweight concrete due to dust shedding. Clay lofts were a fire protection measure to spare the lower house from destruction.

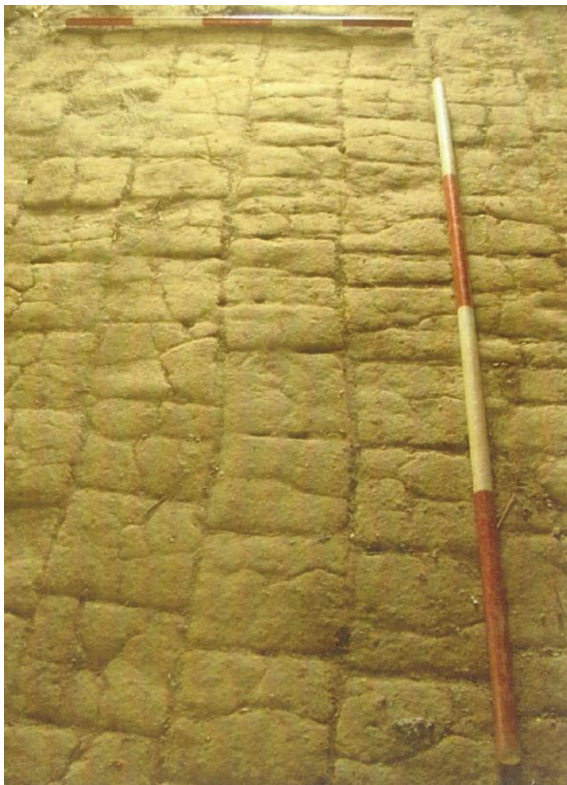
The tiled clay blocks forming the “brandsolder” on the ceiling, as fire proofing for the house below.
