Remains of an early clay building (c.1700), kraal (c.1800) and labourer's cottage (c.1850)

Archaeological Analysis and dating of fabric, by Hennie Vos.

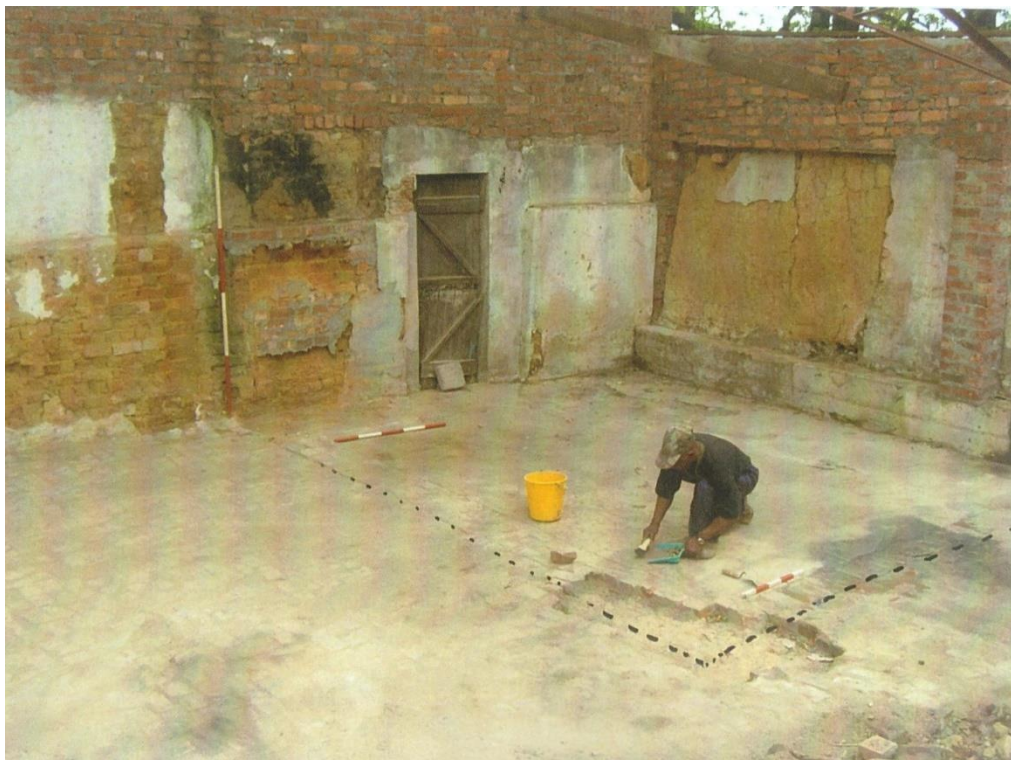
Archaeologist's assistant at work in a section of the covered outside space of "The Venue" (most northern corner) which would have been an earlier cottage (note the soot from the kitchen chimney) with the oldest portion of wall on the farm in yellow clay behind him. This piece of wall is

constructed directly out of clay (rammed/ layered construction), and not built from formed and dried clay bricks and mortar.

A remnant of a c.1685-1700 construction, clay wall of 3.1m long x 2.1m high x 35cm wide was found encapsulated in a later structure. It is built up in layers of 22-28cm of yellow clays found on the farm. It was constructed without any stone foundations. Due to its height, it probably formed part of an earlier building.

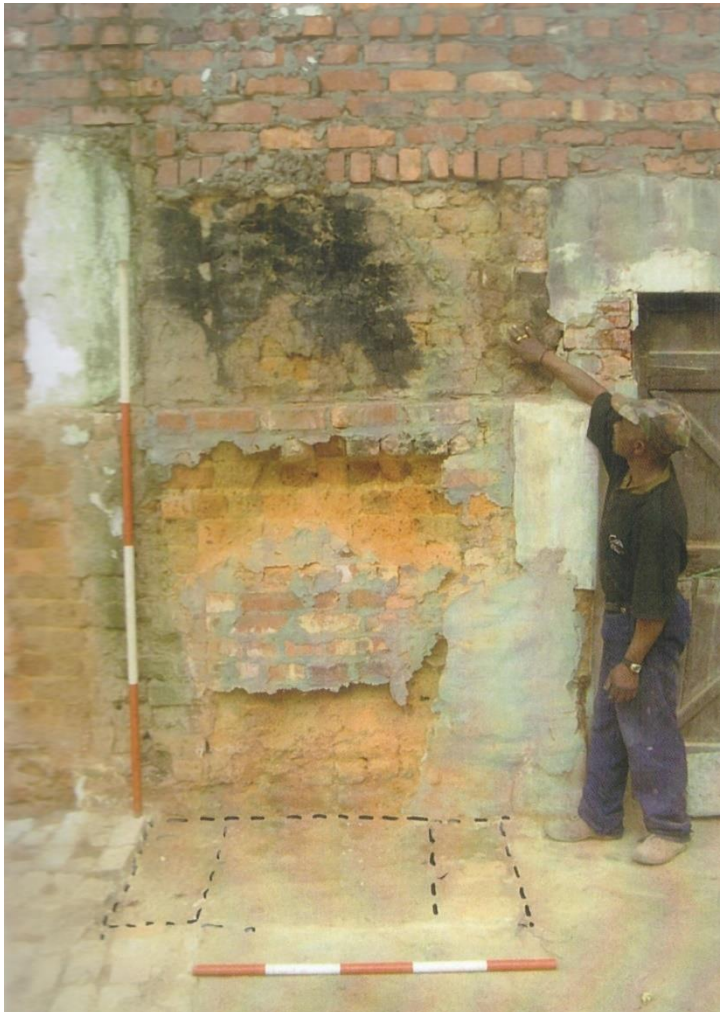
Archaeologist's assistant indicating the remains of a fire place that was discovered here.

A 7m portion of 1800s wall construction remain of an earlier kraal wall and cottage. The 1.5m plinth portion of the wall (40cm thick) dates to c.1800 and had a shaped top, as of a kraal wall. There is a wide gateway opening giving access from the lower wagon road. The upper portion of wall is thinner (30cm) and date to c.1850, and represents an earlier cottage with a hearth. These walls are of a medium fired brick in orange mortars, with old lime or cement plaster.

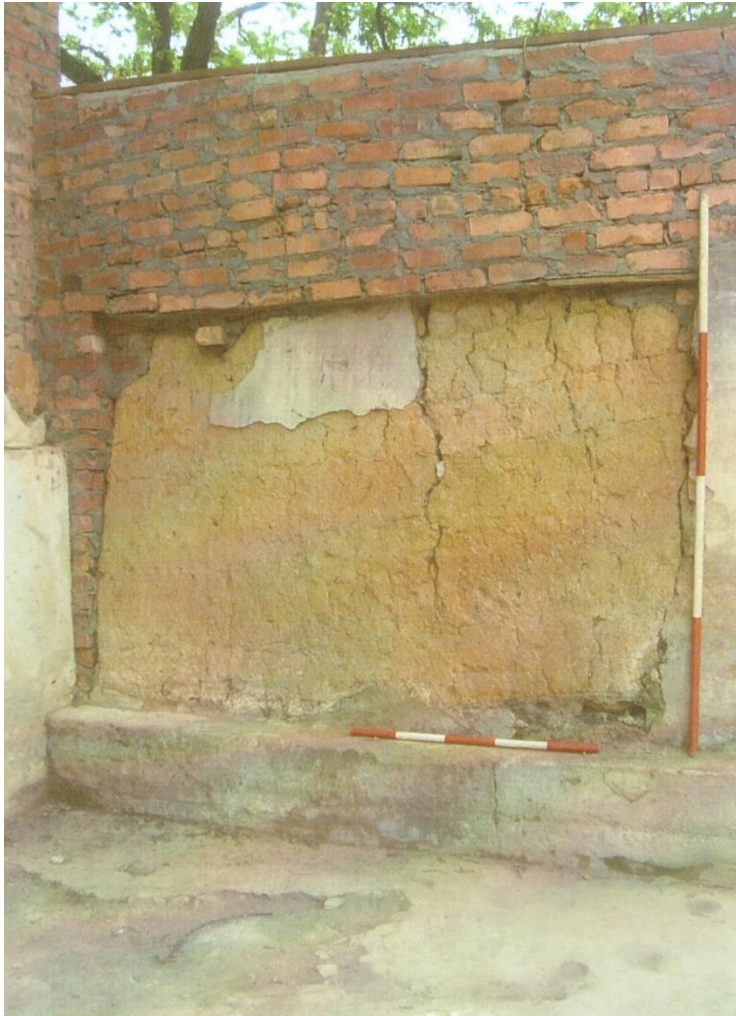
The oldest piece of wall on the farm, which dates to c1685-1700, was constructed with layers of compacted clay. This wall was covered in fresh plaster during the renovation, and is preserved in position.

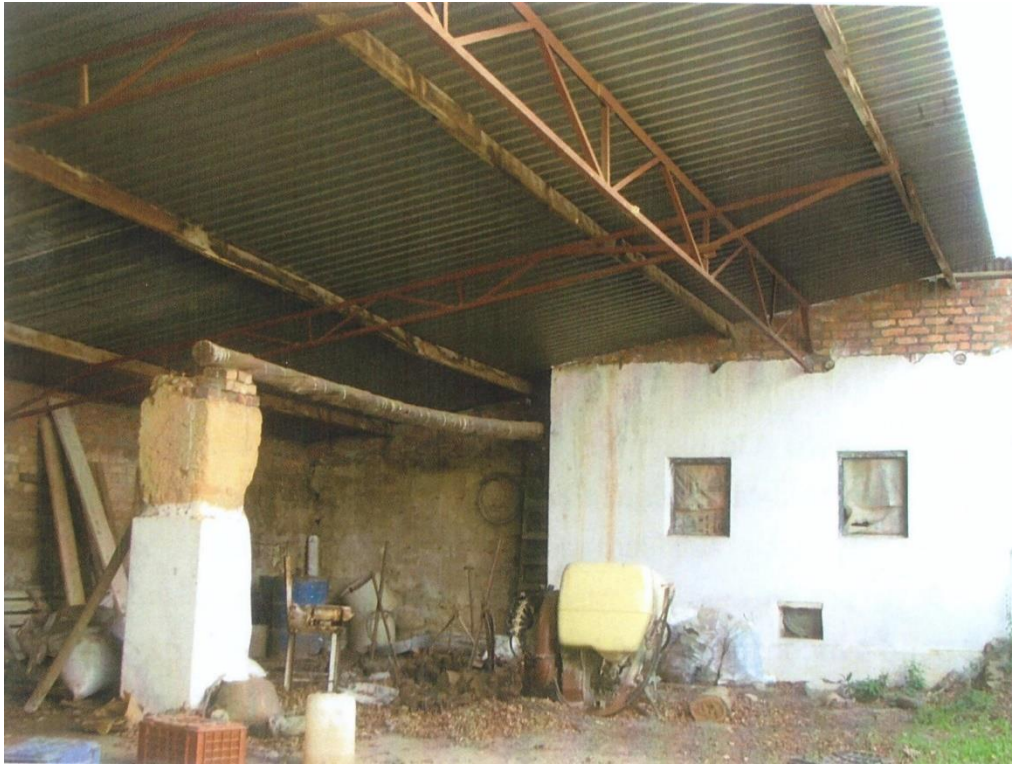
Prior to the reconstruction of a long building with a pitched roof and courtyard space north of “The Venue”, this area had been altered significantly in modern times. The historic building remains found were part of a barn, kraal and cottage. In this photo one can still see the last of what would have been a row of square columns, of the same construction as those at “The Barn.” This column had collapsed prior to the restoration project. All columns present in this location today are reconstructions.

A single column c.1790-1800 was found remaining in the old kraal. It was of the same construction as the columns at the Southern Barn. It has collapsed since.

All this remaining old fabric was enclosed in new plaster and infill brickwork, and now forms part of the roofed outside space at the Northern end of "The Venue." The gateway from the courtyard to the old wagon road below was kept. The building has been reconstructed to fill in the gaps (such as the columns, roof and gables) and has been given a simple long form which approximates the scale, placement and form of the earlier building.
